# Mind the gap

by **InterCem, Germany & Switzerland**

*Cimenterie de Lukala (CILU), majority owned by HeidelbergCement, recently installed a new kiln inlet sealing system in its cement plant in the DR of Congo. The new system resulted in an improved kiln operation and helped ensure a safer working environment for its employees.*

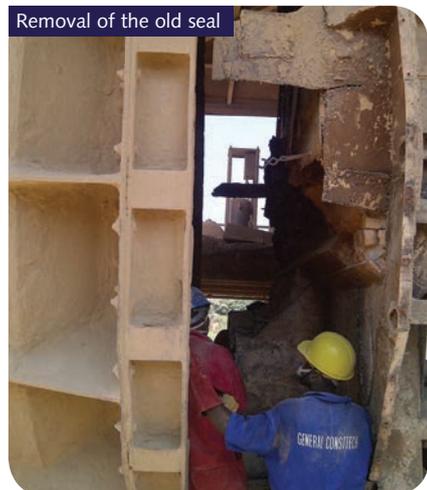
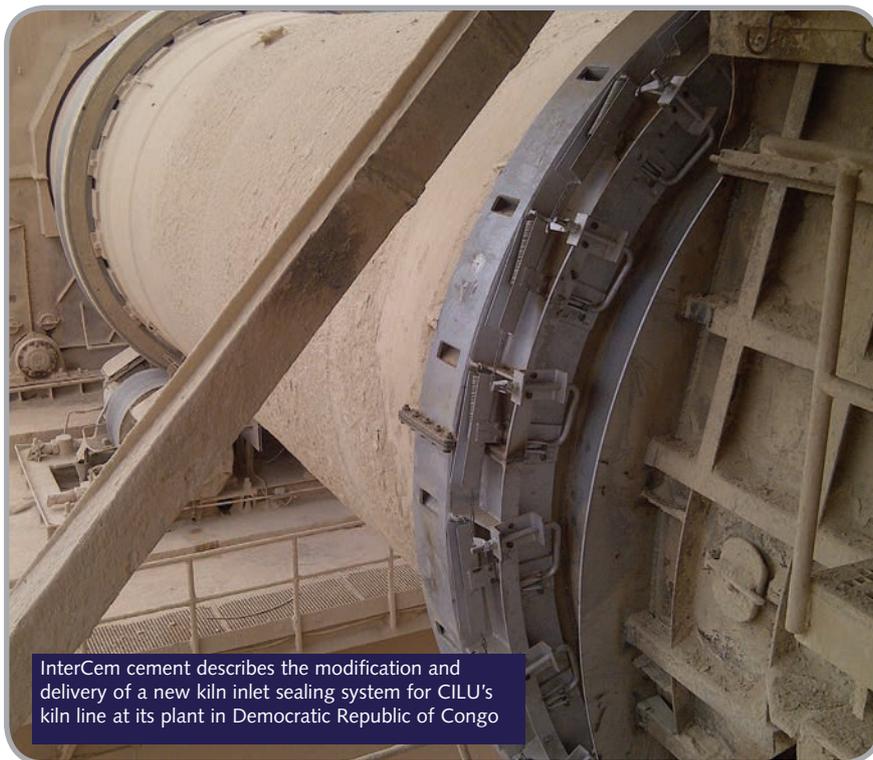
To solve this issue, HeidelbergCement sought to lower and move the inlet troughs to increase the overlap between kiln and inlet and thus reduce the gap. However, it was concerned about the deformation of the kiln lining and

exacerbating an already-considerable issue.

InterCem not only proposed a completely-new design, a kiln inlet sealing system with a retention ring but also made further recommendations:

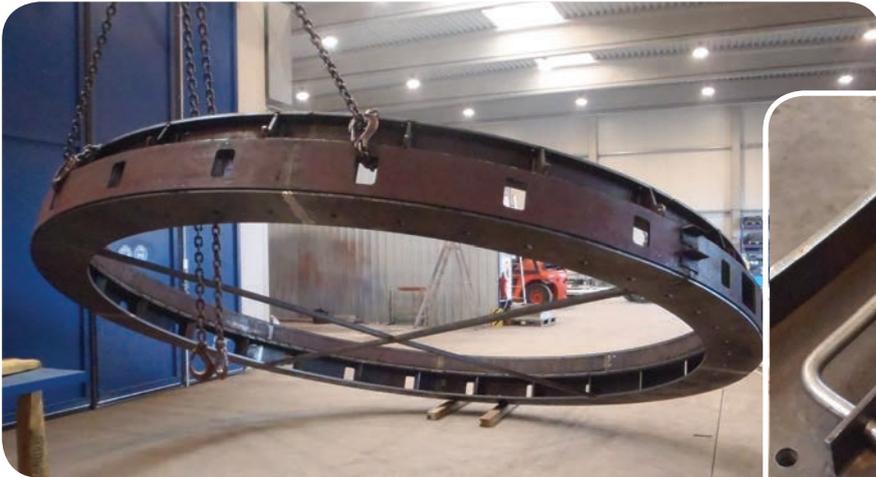
*Thanks to the new kiln inlet sealing system, the CILU works now benefits from an improved and more stable kiln operation with a lower energy consumption.*

Thanks to the new kiln inlet sealing system, the CILU works now benefits from an improved and more stable kiln operation with a lower energy consumption. Furthermore, as raw meal is no longer spilt from the kiln, both clinker quality and volume have seen improvement and staff are no longer facing a considerable safety risk in their working environment.

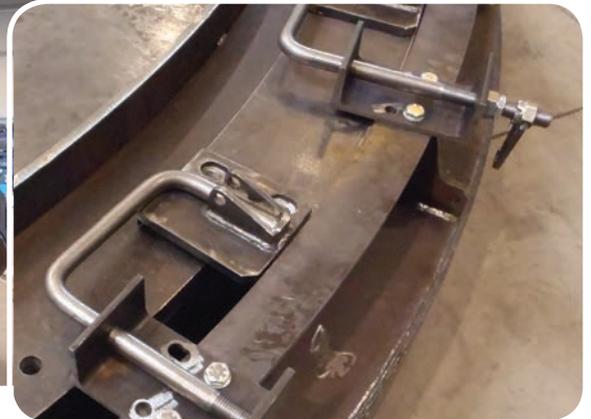
The new kiln inlet seal was manufactured at InterCem's German manufacturing facilities

The new kiln inlet seal was manufactured in Germany to ensure high accuracy. To further guarantee a high precision in roundness of the total unit, the seal was split into segments after manufacturing. The two halves were then containerised and sent to the CILU plant.

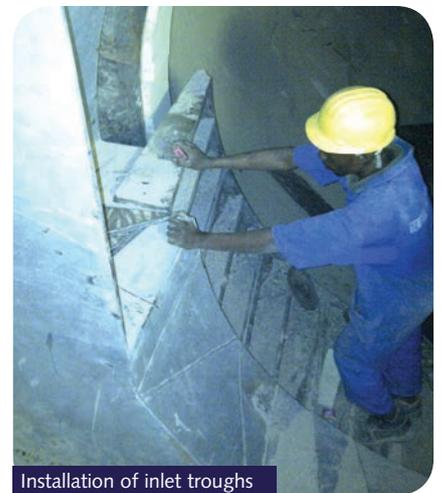
Installation of inlet troughs

Subsequently, the customer installed the new system, under supervision of two InterCem engineers. Heat-resistant nozzles for the aeration system were installed and the kiln inlet area received a new refractory lining. Then followed the installation of heat-resistant cast-iron kiln inlet troughs as well as the new kiln inlet sealing and corresponding refractory lining. The new system also saw the placing of new shock blowers. Finally, the project reached its final commissioning stage where fine-tuning of the sealing was performed, again under InterCem supervision.

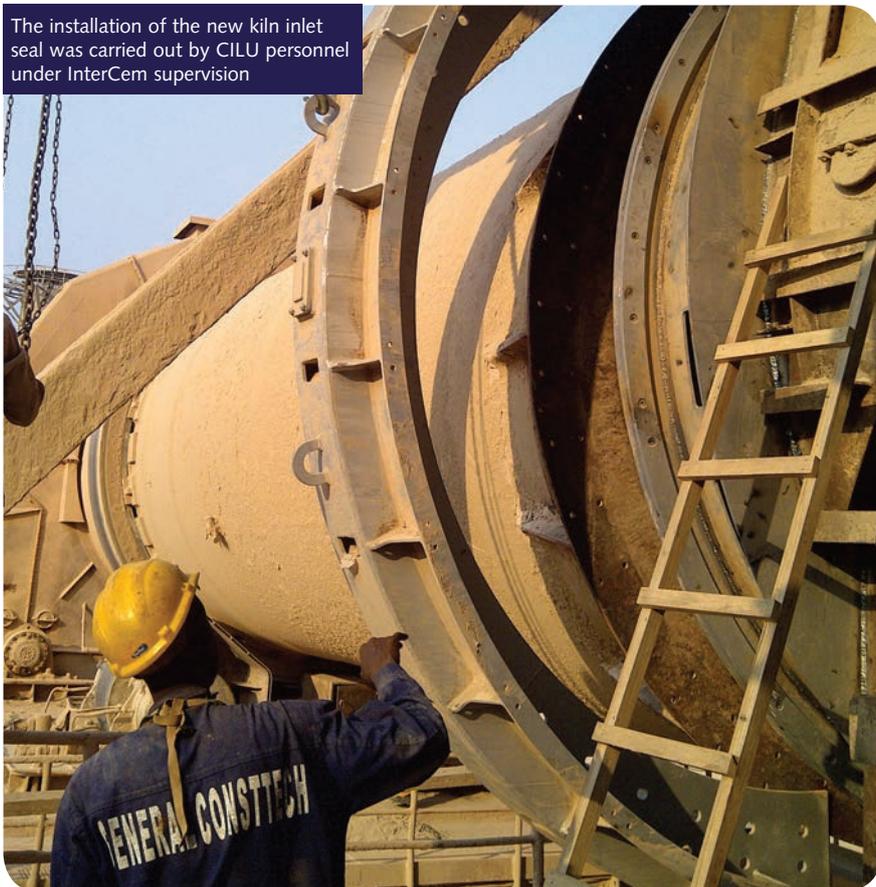
The installation of the new kiln inlet seal was carried out by CILU personnel under InterCem supervision
