1 Total overview of kiln line 3 after rehabilitation job

INTERCEM

## Kiln rehabilitation in Tanzania

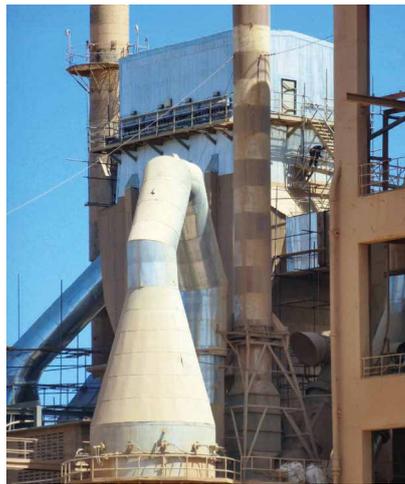
2 Filter Conversion from ESP to Bag Filter

- » Conversion of the furnace filter from ESP to bag filter based on a CFD (Computational Fluid Dynamics) flow analysis. This base is the constructive outcome after reconstruction of the ESP filter bag filter (Fig. 2)

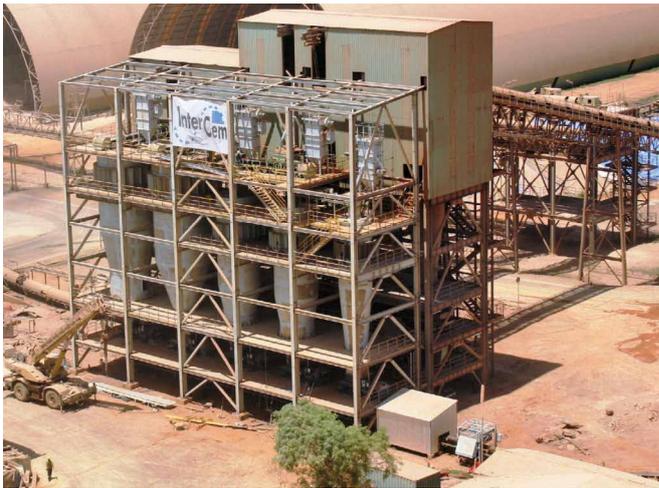
**3** New raw material preparation station for HGL / LGL / Gypsum, red soil and iron ore

- » Expansion of the raw material warehouse, including stackers and reclaimers
- » Establishment of a “Raw material preparation station” with X-ray analysis and state-of-the-art extraction technique for some very wet and sticky material (Fig. 3)

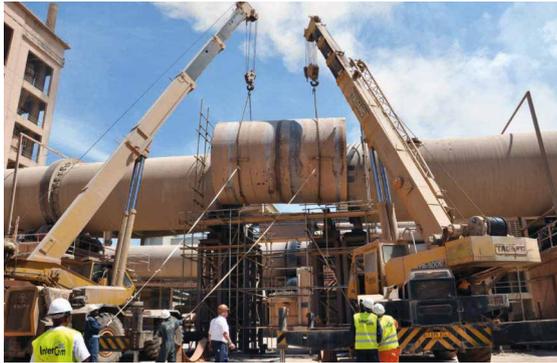
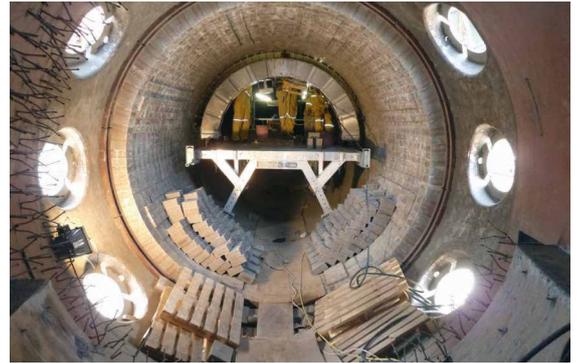
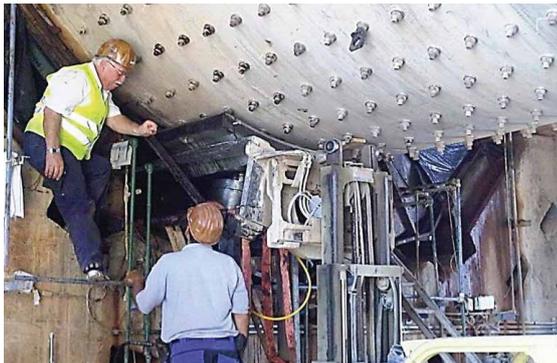
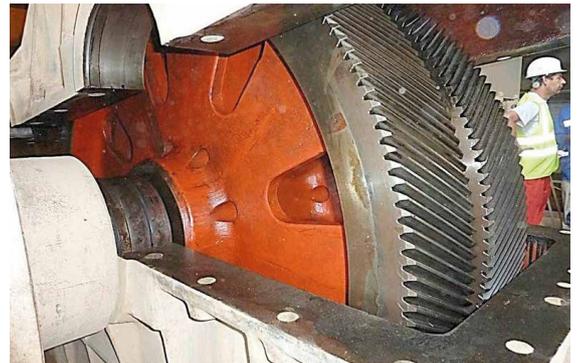
5 Installation of new kiln section

The logistical and administrative problems continued through the commissioning phase. Poor water quality, inadequate air supply, a small amount of cooling water and the daily “power cuts” led to delays, so that the first clinker was produced a few weeks late in July 2012. Despite the difficult circumstances it was possible for the Intercem specialists to bring the system to a stable operation in a relatively short time, so that the retreaded kiln line (Fig. 5) could be handed over to the customer with an FAC (Final Acceptance Certificate) in December 2012.

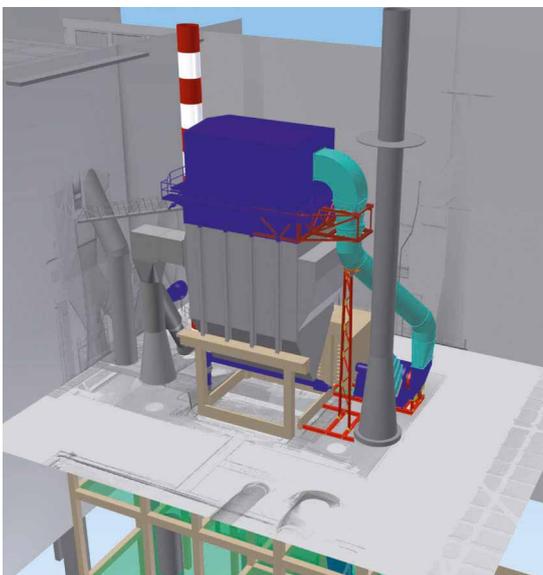
6 Engineering with 3D Scanning system

Due to the lack of “as-built drawings” the original situation of many plant parts was recorded with a special 3-D scanner. This resulted in a very high degree of planning (Fig. 6) and ensured accuracy, which in turn was reflected in flawless plans. This became clear during assembly, as delays and additional costs resulting from design errors did not occur at Wazo Hill.

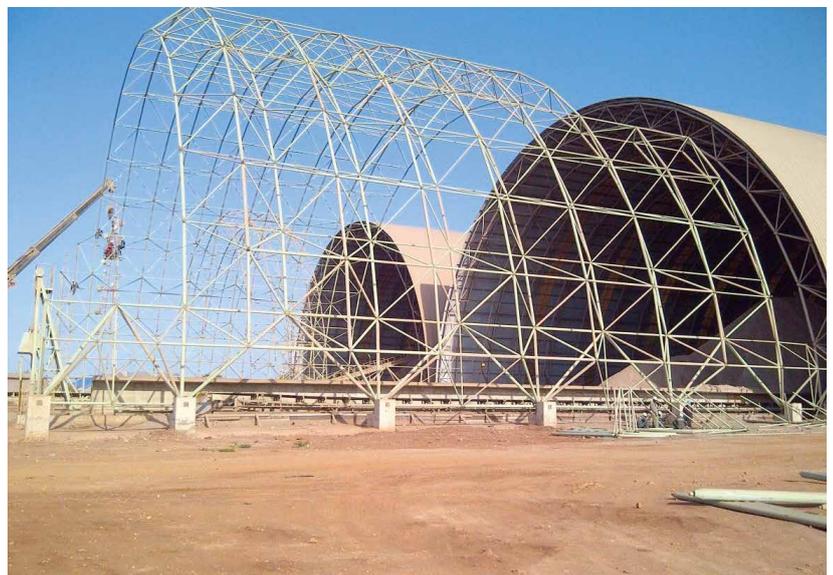
7 Extension of the raw material storage

By installing the raw material preparation and the X-ray analyzer, a significant improvement of clinker and cement quality was possible. Furthermore, the homogenization in the extended raw material section (Fig. 7) has resulted in constant production conditions in the heat exchangers and the rotary kiln. Altogether, this has increased the availability of the entire system.
